Wasco County Soil & Water Conservation District

Re: Middle Columbia–Hood (Miles Creeks) Temperature TMDL – SWCD Comments

Appendix A
Site Capable Vegetation: Reference Sites

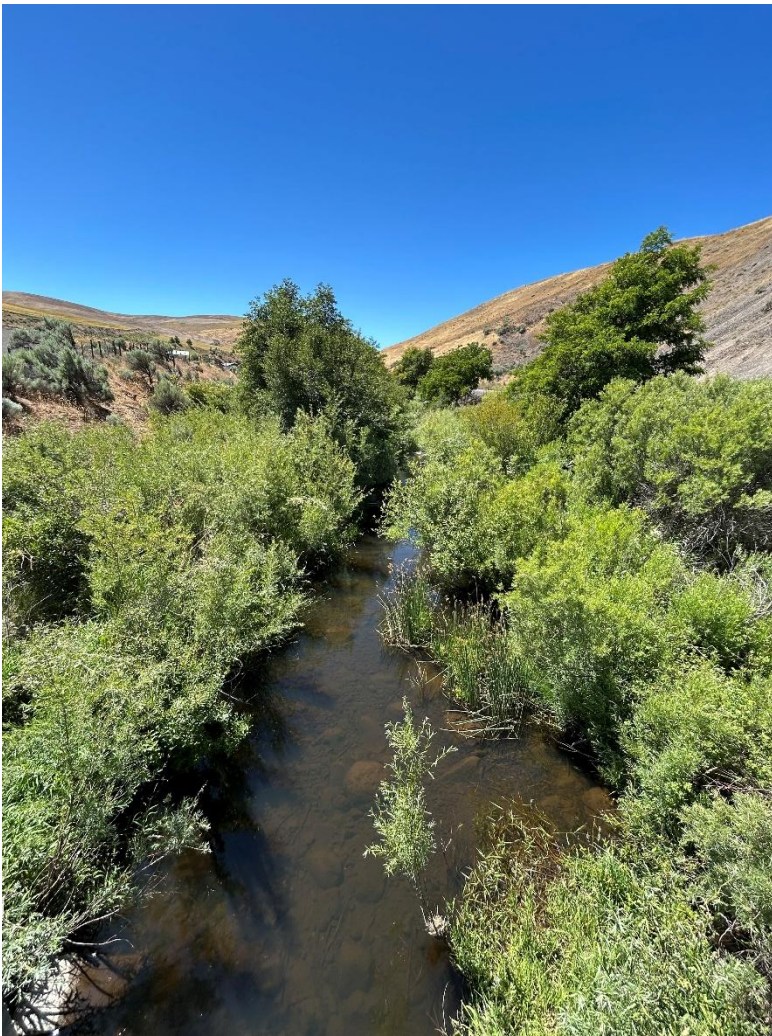
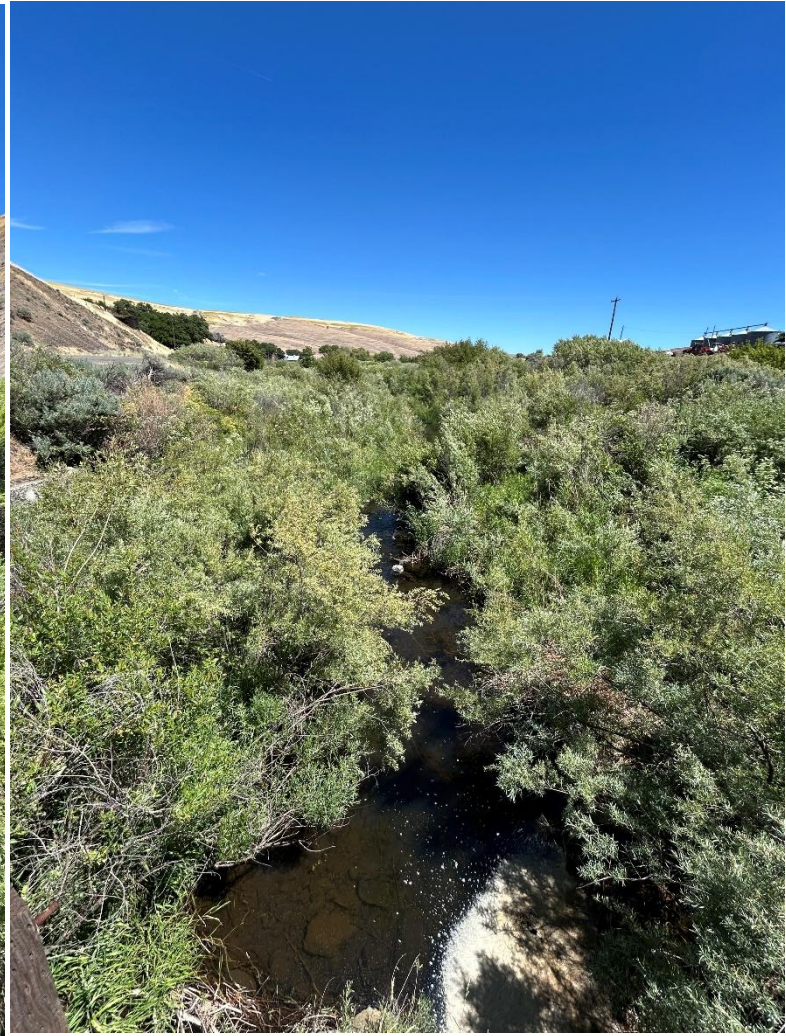
Site 1: The pictures below show an upstream and downstream look from Company Hollow bridge on lower Fifteenmile Creek. The riparian area shown is one of the oldest CREP buffers on Fifteenmile Creek, and has also benefited from a floodplain restoration project done just upstream from the site many years ago. The site is characterized by large woody shrubs, primarily willow; but has an almost complete absence of channel spanning, canopy creating vegetation.

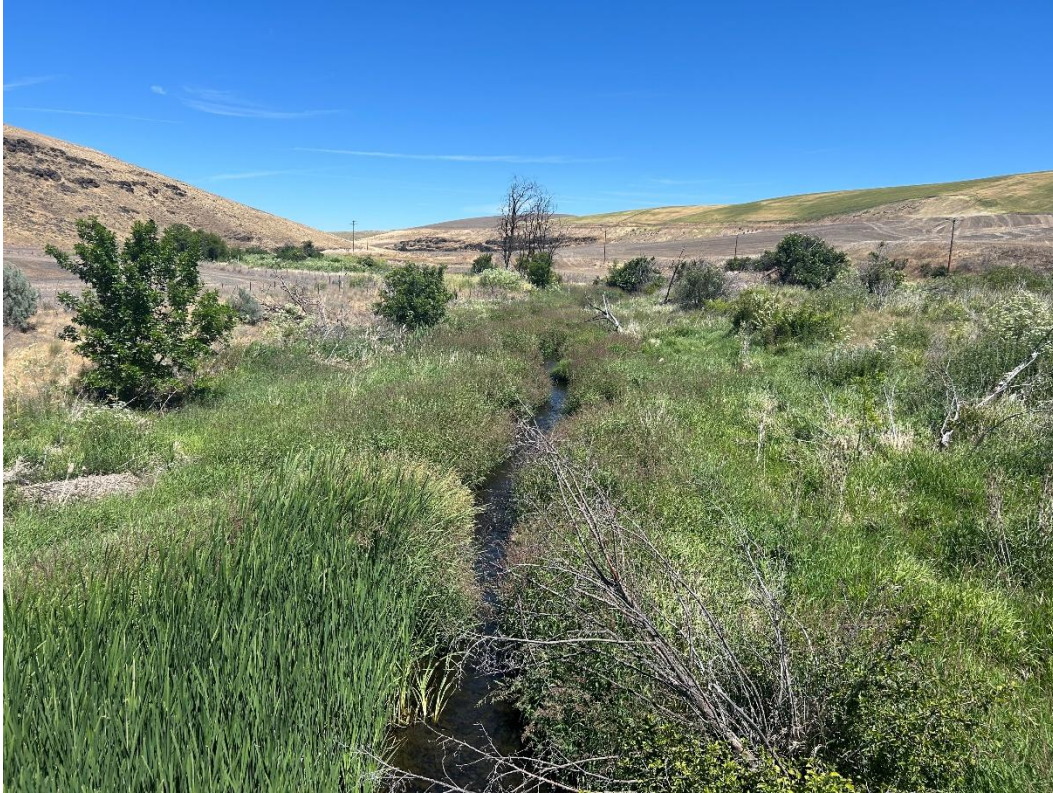
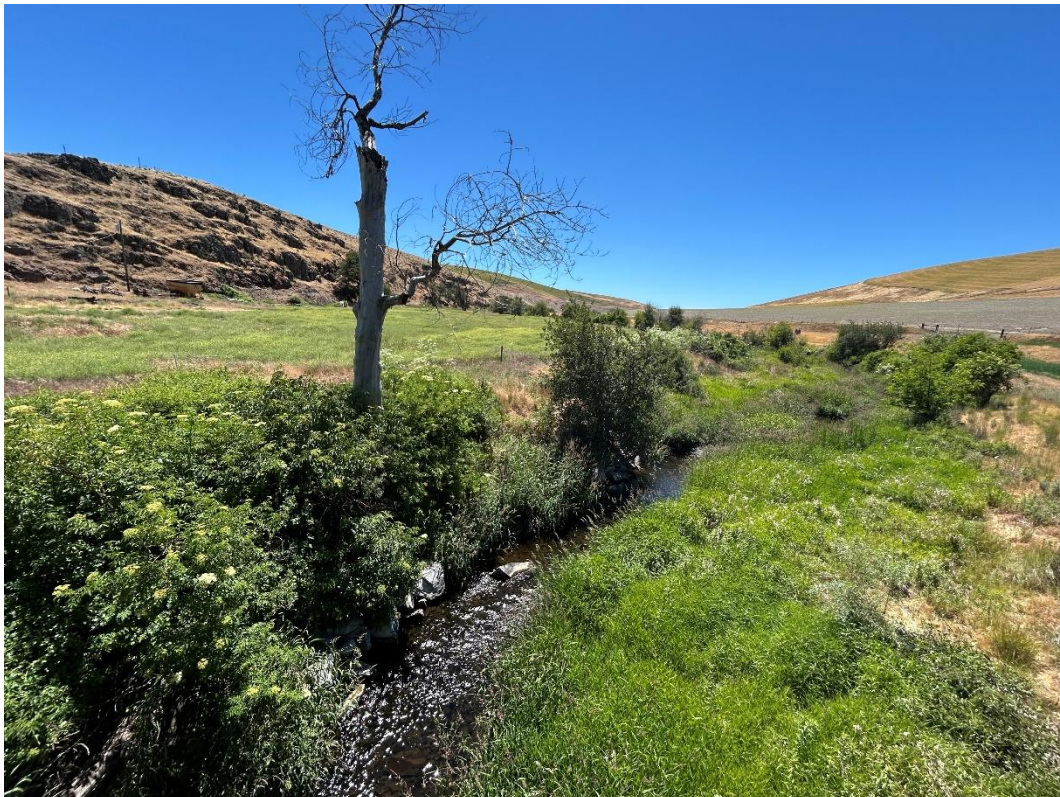
Site 2: Below are pictures from buffers along the stretch of Fifteenmile that runs along Wrentham Market Road. This site is characterized by extremely frequent fire intervals, shifting the plant community from the woody shrubs seen in site 1 to more herbaceous species. While there are some woody species hanging on, such as the elderberry near the camera in photo 2; they often don't have a chance to reach shade creating sizes due to frequent disturbance.
